PM5357

S/UNI-622-POS

**SATURN USER NETWORK INTERFACE
(622-POS)**

ERRATA

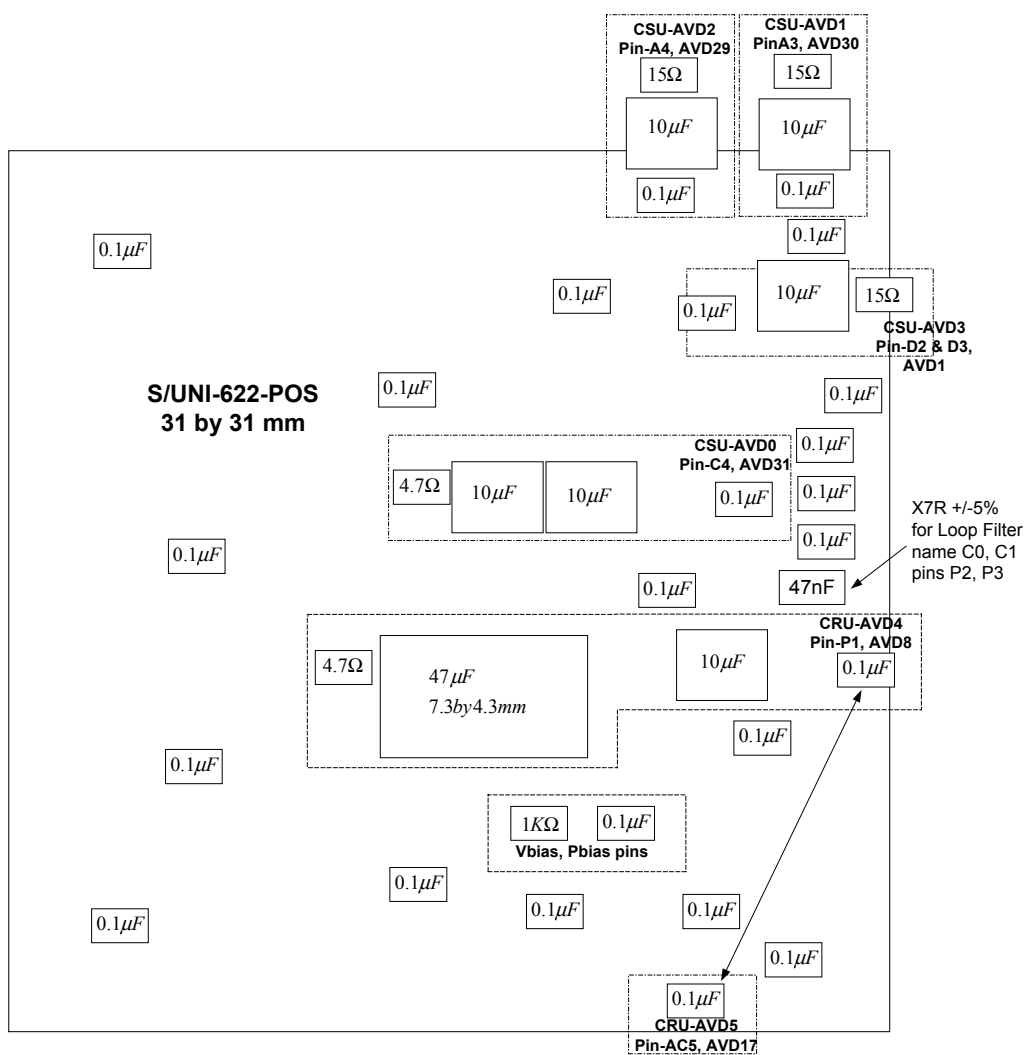
Power Supply Component Layout

2.1 Power Supply Filtering Mechanical Drawing Incorrect (Pg. 339, Section 13.14)

The loop filter capacitor recommendation specifies a 47nF capacitor not a X7R 47uF capacitor as shown in the datasheet. The correct figure is shown below:
