8x930Hx (8x930HD/HE & 8x930HF/HG) SPECIFICATION UPDATE

Release Date: February, 1999

Order Number: 272962-013

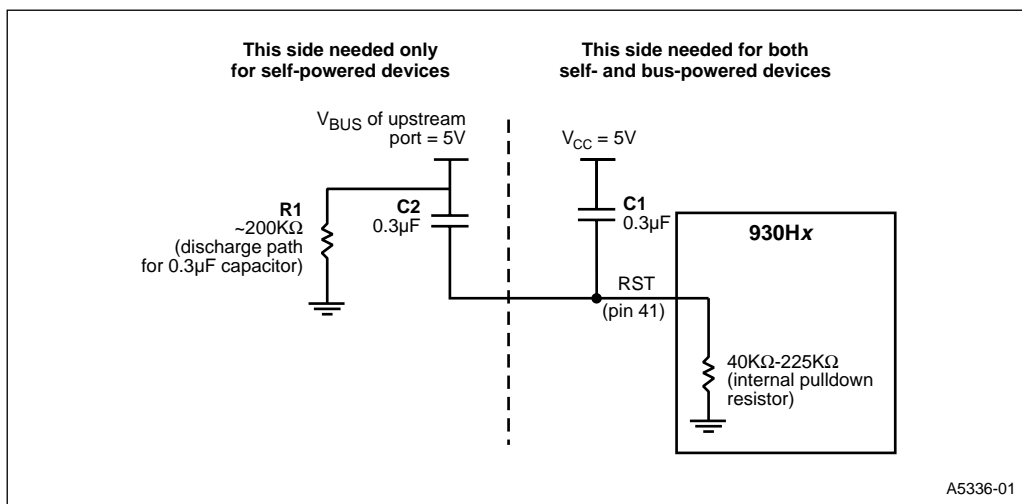
Figure 1. RST Source From V_{CC} and V_{BUS}

PROBLEM: When a self-powered, suspended hub is reattached to the host, it could be accidentally recognized as a low-speed device. This is caused by the 8x930Hx A-1 driving K signaling upstream and the host incorrectly sampling the speed of the device immediately after connect instead of after USB reset.

IMPLICATION: Enumeration will fail due to the host sending low-speed packets to a high-speed device.

- C1 — Used in conjunction with the internal pulldown resistor to generate a 20 ms pulse of reset. For bus-powered devices, $V_{CC} = V_{BUS}$. This creates a 20 ms pulse upon connection to the host. For self-powered devices, a 20-ms pulse will occur regardless of the state of V_{BUS} if the capacitor ratios remain 1:1. The circuit operation and timing relationships rely on $C1 = C2$.
- C2 — Used only for self-powered devices. The capacitor delivers a 20-ms pulse to the RST pin when the V_{BUS} signal is detected upon device connection.
- R1 — Provides a discharge path for C2. This resistor is mandatory. If R1 is not present, C2 will not discharge the reset pulse and therefore will not allow a proper chip reset during device connection.

WORKAROUND: To fix this problem, you must modify the reset circuitry on current 8x930Hx designs. **Figure 1** depicts two circuits, one for a bus-powered hub and another for a self-powered hub. For bus powered devices, the circuit is the same one that is given in Figure 14-1 on page 14-1 of the *8X930Ax, 8X930Hx Universal Serial Bus Microcontroller User's Manual*, except the capacitor value has been changed from 1.0 μ F to 0.3 μ F.

For self-powered devices there are two requirements:

- The reset circuit design needs to be activated when the board is first powered-on.
- If the board is already powered-on, then a connection to the host should initiate reset. By connecting another capacitor to V_{BUS} (C2, as shown in **Figure 1**), a reset pulse is sent to the chip by either a power-up or by a USB connect.

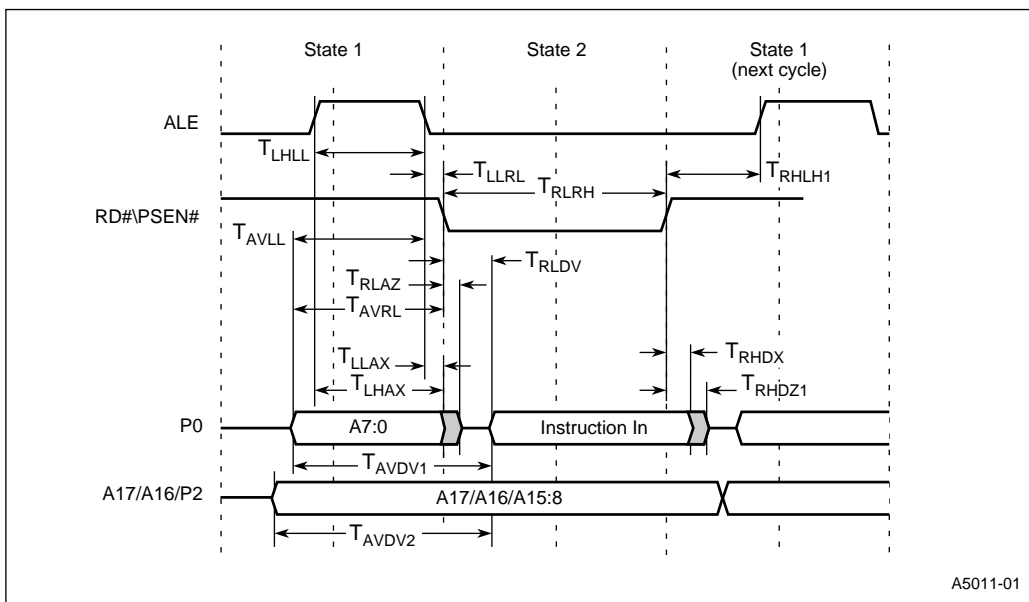
Figure 5. External Code Fetch, Nonpage Mode

PROBLEM: The T_{RHDZ1} (Instruction Float After RD#/PSEN# High) specification on the 8x930Hx when operating at 12 MHz is 10 ns. However, a slow memory device such as an EPROM typically takes approximately 30 – 90 ns to float its output. (This specification, generically called $TPHZ$, may vary depending on the memory type and manufacturer.) Figures 5 and 6 illustrate the T_{RHDZ1} timing.

The difference between the T_{RHDZ1} and $TPHZ$ specifications causes contention on the data bus (P0 in nonpage page, P2 in page mode). The 8X930Hx begins to drive the address for the next bus cycle while the memory device is still driving data from the previous bus cycle.

To prevent this contention, designers can use a buffer to isolate the output of the memory device from the data bus (port 0 or port 2) of the 8x930Hx. This will prevent the memory device from driving the data bus during the critical period after T_{RHDZ1} expires. We suggest a buffer such as the 74F541 octal, three-state line driver shown in [Figure 7](#).

When PSEN# goes high after a read, OE1# and OE2# are deasserted, and the buffer's output switches to the high-impedance state in approximately 9.5 ns (T_{PHZ} for a typical 74F541; the value may vary from one manufacturer to another). Thus, contention on the data bus is prevented. This or a similar hardware solution is recommended for 8X930Hx designs in which memory devices do not meet the TRHDZ1 timing specification.
