Errata Revision: *C

May 02, 2007

RAM9 QDR-I/DDR-I/QDR-II/DDR- II Errata

This document describes the $\overline{\text{DOFF}}$ issue for QDRII/DDR II and the Output Buffer and JTAG issues for QDR I/DDRI/QDR II/DDR II. Details include trigger conditions, possible workarounds and silicon revision applicability. This document should be used to compare to the respective datasheet for the devices to fully describe the device functionality.

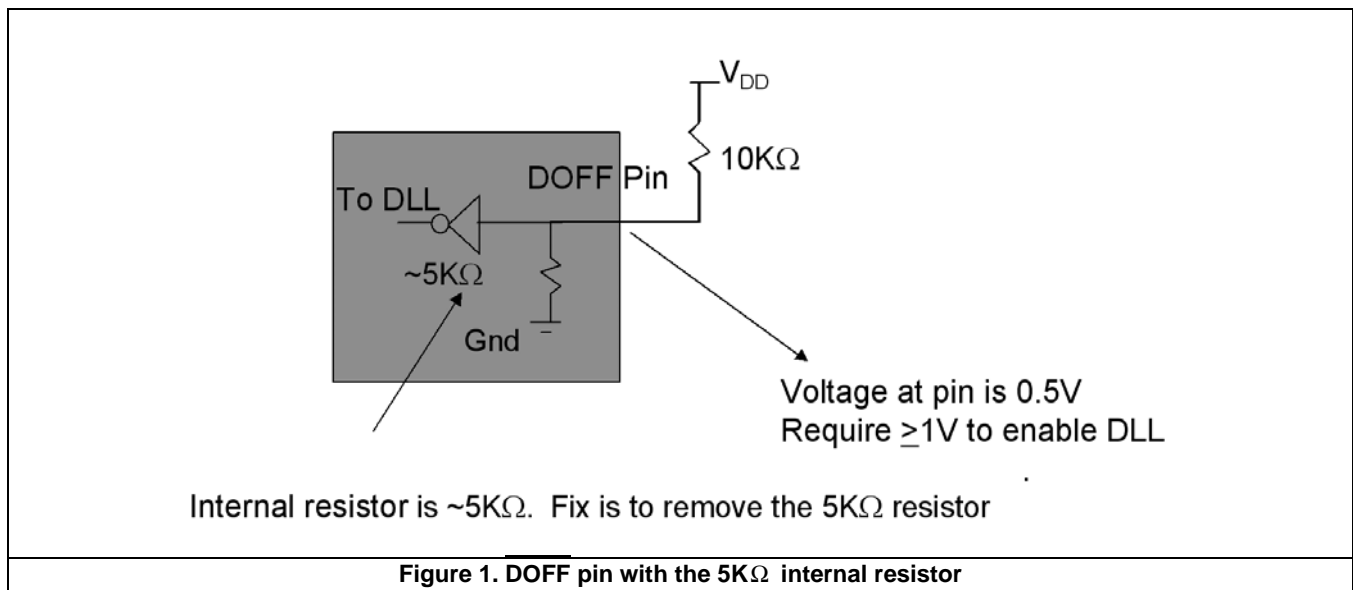
This issue involves the DLL not turning ON properly if a large resistor is used (eg:-10K Ω) as an external pullup resistor to enable the DLL. If a 10K Ω or higher pullup resistor is used externally, the voltage on DOFF is not high enough to enable the DLL.

Having a 10K Ω or higher external pullup resistor for disabling the DOFF pin.

Figure 1 shows the DOFF pin circuit with an internal 5K Ω internal resistor. The fix planned is to disable the internal 5K Ω leaker.

Fix involved removing the internal pull-down resistor on the $\overline{\text{DOFF}}$ pin. The fix has been implemented on the new revision and is now available. The new revision is an increment of the existing revision. The following table lists the devices affected, current revision and the new revision after the fix.

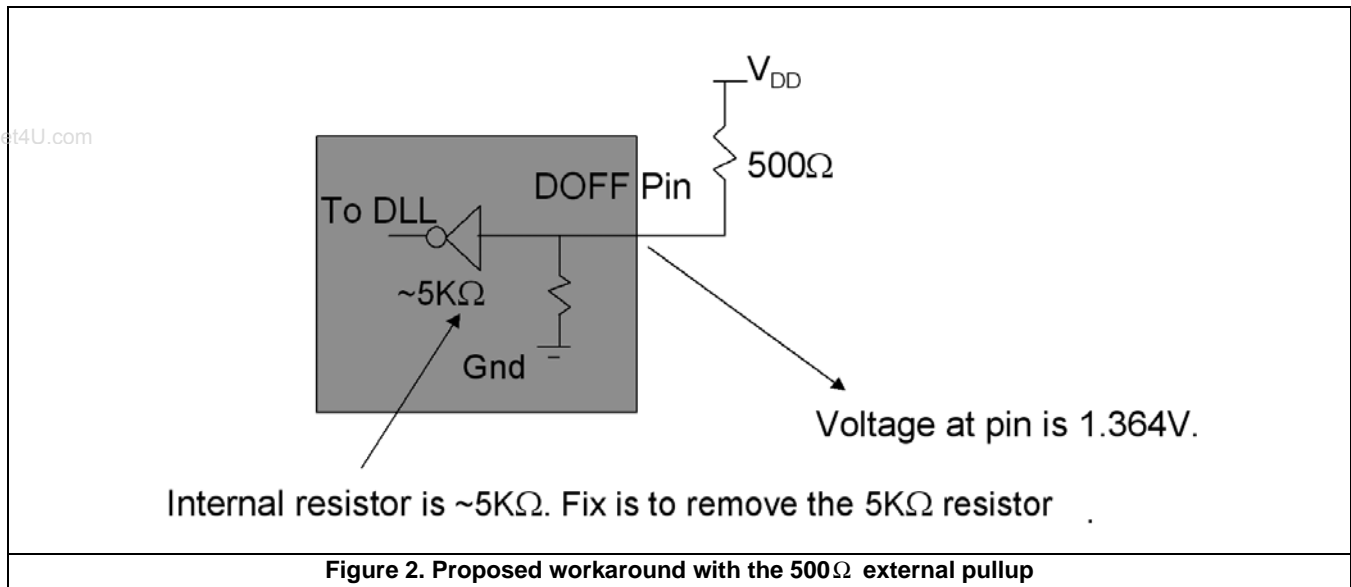
Figure 2 shows the proposed workaround and the fix planned.

The workaround is to have a low value of external pullup resistor for the $\overline{\text{DOFF}}$ pin (recommended value is $\leq 500\Omega$). When $\overline{\text{DOFF}}$ pins from multiple QDR devices are connected through the same pull-up resistors on the board, it is recommended that this $\overline{\text{DOFF}}$ pin be directly connected to V_{DD} due to the lower effective resistance since the "leakers" are in parallel.

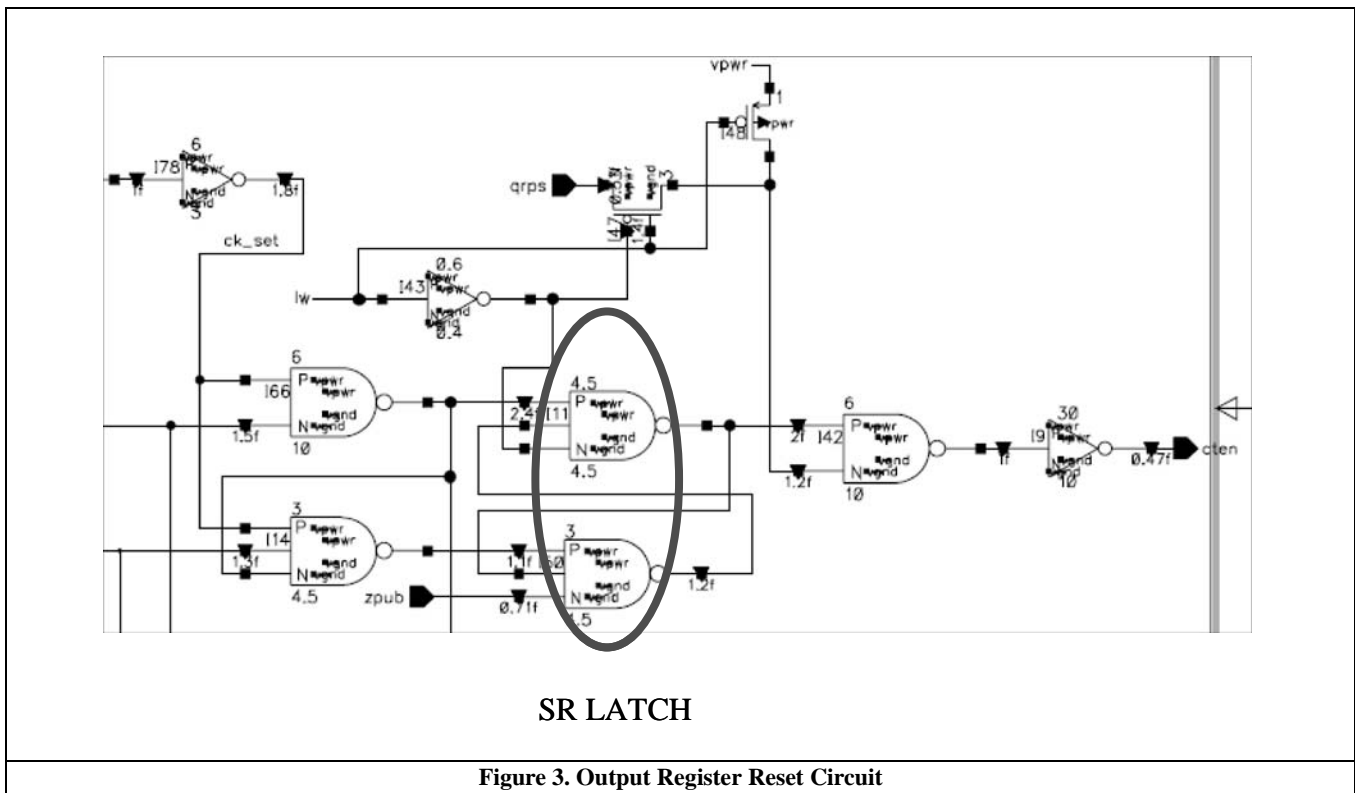
This issue involves the output buffer entering an unidentified state when the input signals (only Control signals or Clocks) are floating during reset or initialization of the memory controller after power up.

Input signals (namely RPS# for QDR-I/QDRII, WE# and LD# for DDR-I/DDRII) or Clocks (K/K# and/or C/C#) are floating during reset or initialization of the memory controller after power up.

Figure 3 shows the output register Reset circuit with an SR Latch circled. This latch has two inputs with one of them coming from some logic affected by the clock and RPS#(QDR) or WE# and LD#(DDR). The issue happens when clocks are glitching/toggling with controls floating. This will cause the SR latch to be taken into an unidentified state. The SR Latch will need to be reset by a dummy read operation if this happens.

The fix has been implemented on the new revision and is now available. The new revision is an increment of the existing revision. Please refer to Table 4 for the list of devices affected, current revision and the new revision after the fix.
