ST75C520 REVISION 1.4

I - INTRODUCTION

The purpose of this document is helping the customer to use the Revision 1.4 of the ST75C520. So the ST75C520 Revision 1.4 Application Guide answers some questions as :

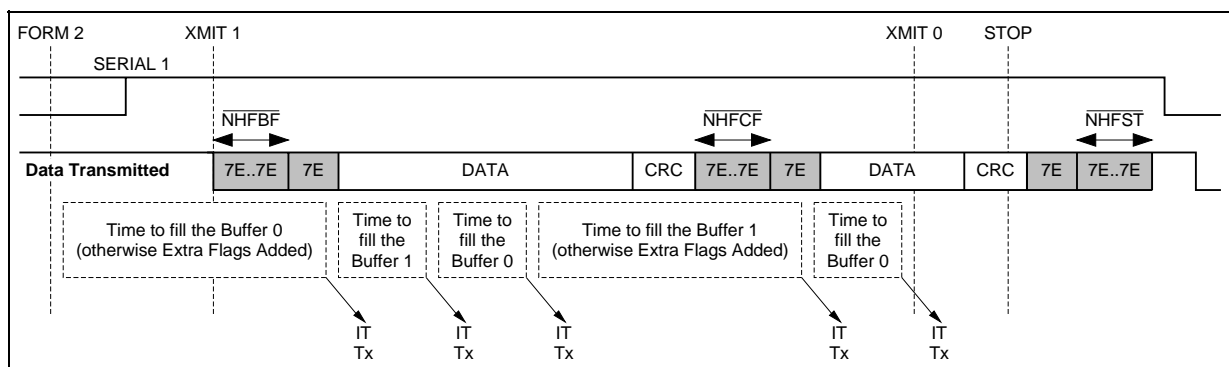
Figure 1 : Detailed Timing Diagram

The default value for these three variables is 0. The programming range is from 0 to 7FFF (32767) (see Figure 1).
